## COMPLETE DENTURE WITH METAL DENTURE BASE: A CASE REPORT.

*Polymethyl methacrylate exhibits excellent physical properties. Unfortunately, complete dentures fabricated from this material may still fracture. The fracture of acrylic resin dentures is an unresolved problem in Prosthodontics. Metal framework reinforcement is used in complete dentures to improve the fracture resistance, dimensional stability, accuracy, weight, and retention of a definitive prosthesis. A potential method of preventing this fracture is metal reinforcement of the palatal portion of the prosthesis. A technique will be presented describing a sequence that incorporates predictable design, fabrication and finishing of a metal palate for a maxillary complete denture.*

An 83 year old male patient reported to department of Prosthodontics with a chief complaint of fractured lower denture in the midline region and attrited teeth in the upper metal denture base and patient wanted a new set of dentures.

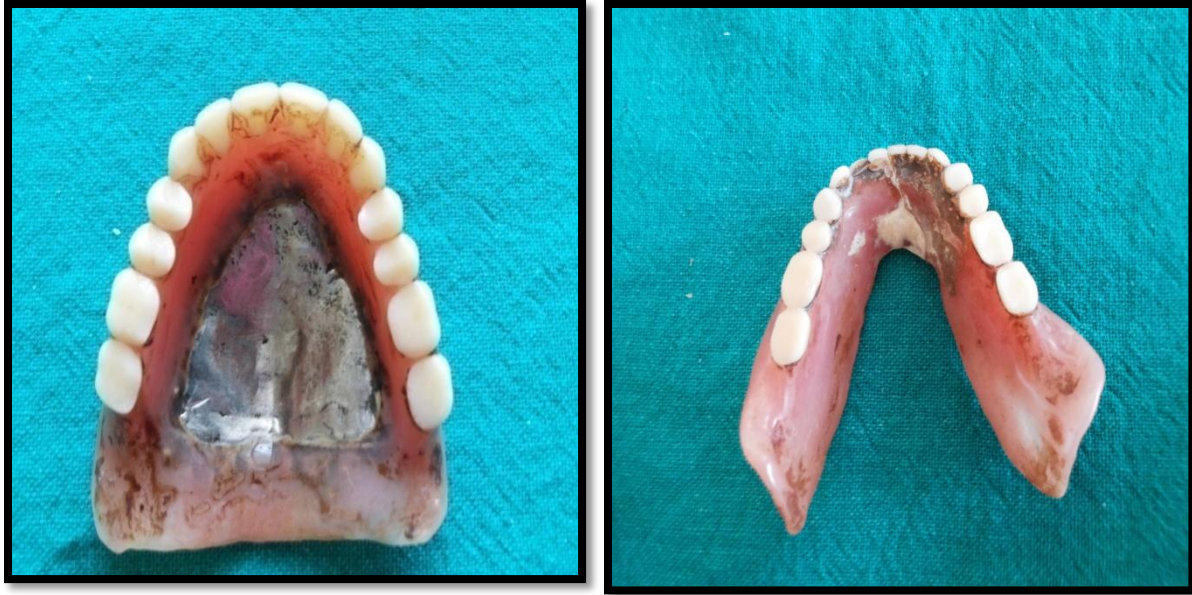
On examination, patient had class I ridge relation, with normal inter arch (20mm) space, midline fracture of lower denture extending from the interdental region between lower central incisors till denture flange area and attrited teeth in the upper metal denture (fig 1). Lower denture was temporarily stabilized with self cure acrylic resin.

Figure 1: Attrited teeth in upper denture and midline fracture of lower denture extending from interdental region of central incisor to flange area.

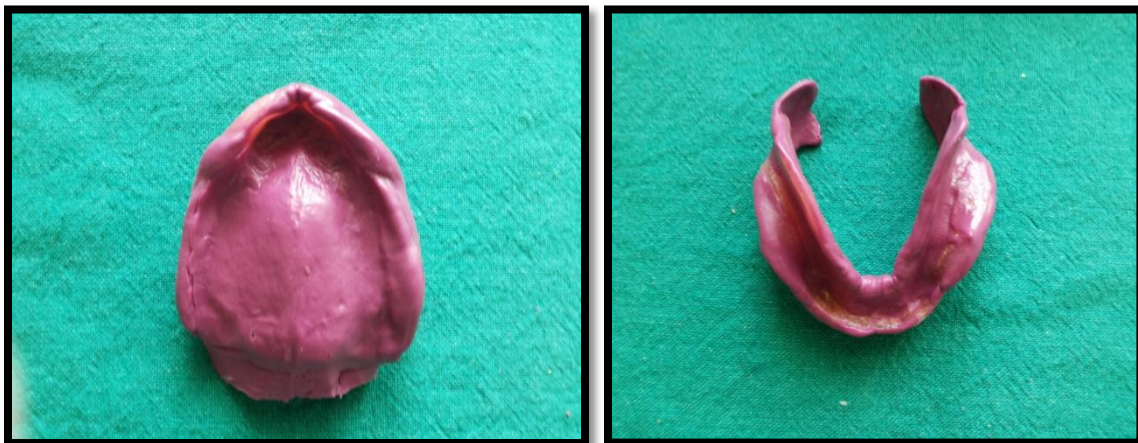
Primary impression was made by using denture with elastomeric impression material. (fig 2) Cast was poured with plaster of Paris, custom tray was fabricated and border moulding was performed with low fusing type I impression compound (green stick). The final wash impression was made with low viscosity zinc oxide eugenol impression paste. Master cast was poured with dental stone.

Figure 2: Primary impression made with elastomeric impression material

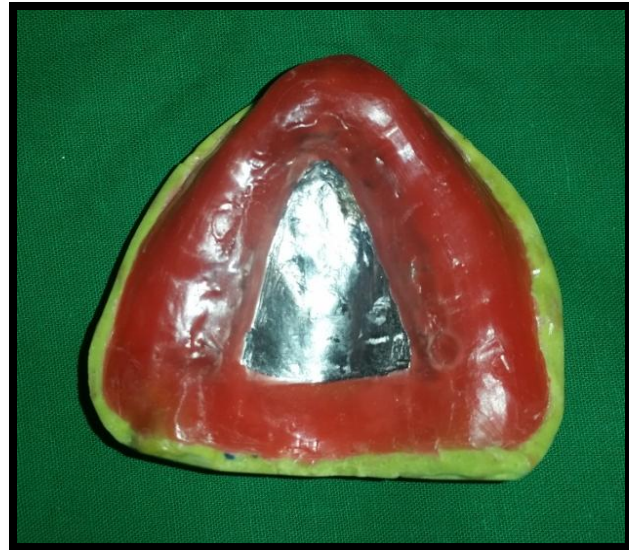
Wax pattern was made for denture base, (fig 4) flasking, dewaxing and packing done with heat cure acrylic resin. (fig 5) Wax occlusal rim was made and Jaw relation was carried out conventionally to record vertical and centric relation. (fig 6)

Figure4: Metal base and wax for smooth denture base

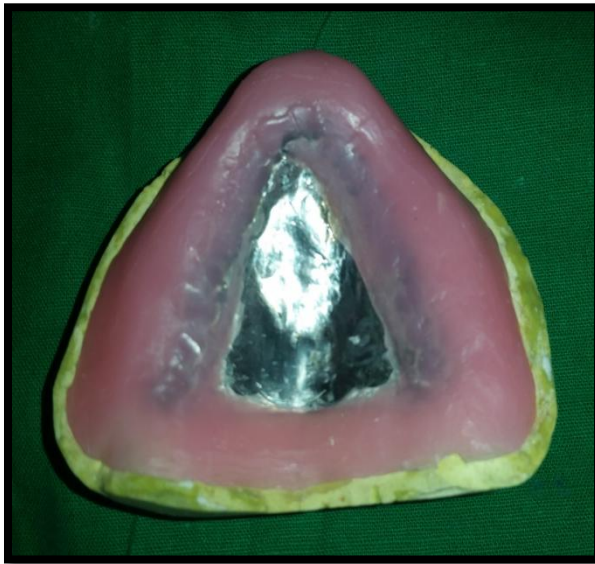
Figure5: Metal denture base

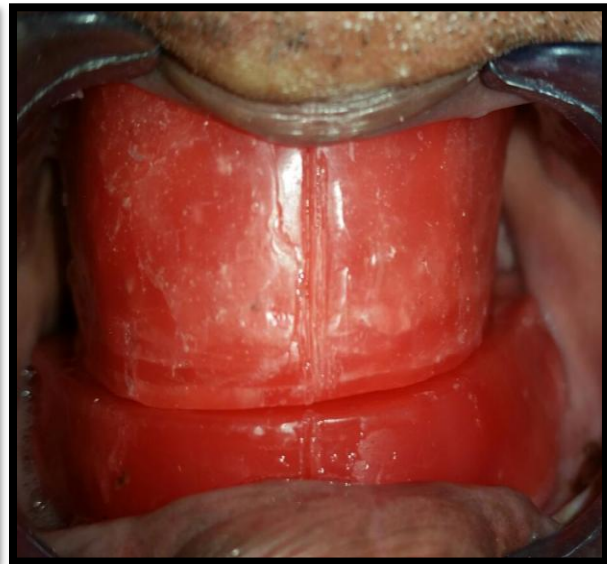
Figure6: Jaw relation done

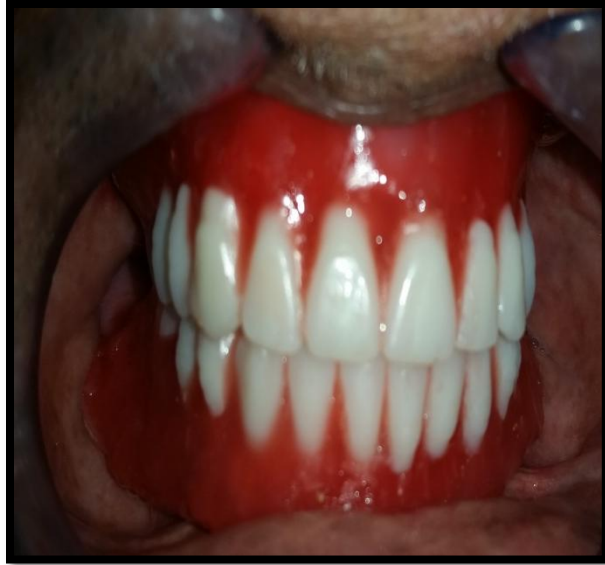
Teeth arrangement was done in a conventional manner in class I molar relation. Try in was done (fig 7) and acrylization of denture done with heat cure acrylic resin. Denture insertion was carried out.(fig 8) Post insertion instructions were given regarding denture maintenance and oral hygiene.

Figure7: Try in done

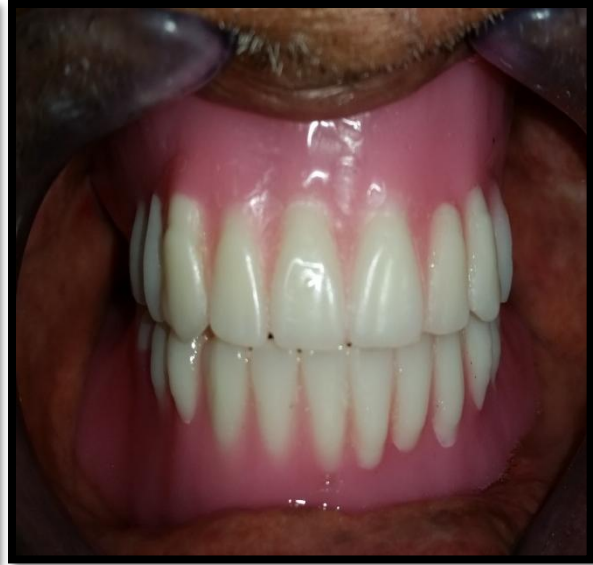
Figure8: Denture insertion

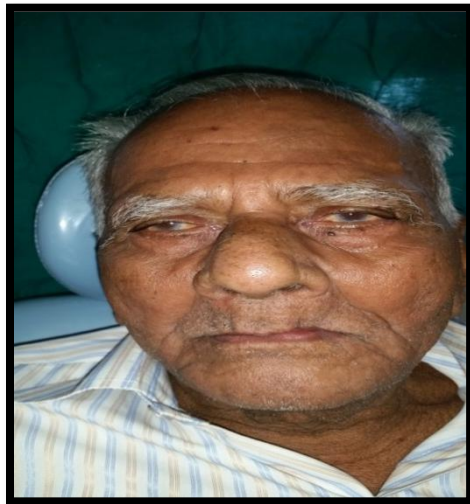
Figure9: Preoperative

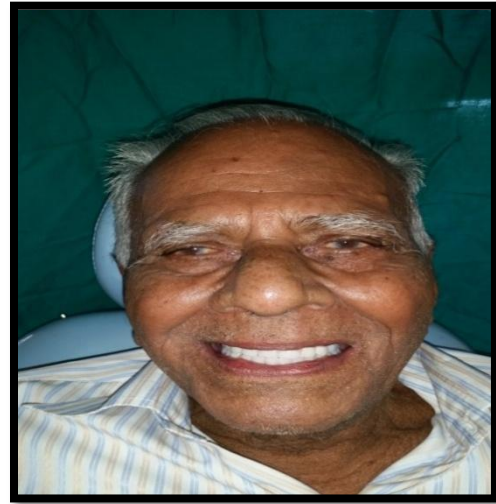
Figure10: Post operative

selection, which in turn will ensure treatment efficacy and effectiveness. The treatment modality of maxillary metal base and opposing natural dentition provided great comfort to the patient as the metal denture base was strong to resist catastrophic failure solving patients chief complain of recurrent fracture in addition the metal denture bases are good thermal conductors and less bulky thus patient perceive natural feeling from thin base which may also contribute to additional denture stability.
